**SITE SUMMARY REPORT
Camp Davis Landfill
NONCD 0000683
Onslow County**

**North Carolina Highway 50
Holly Ridge, North Carolina 28445**

Senate Bill 1492
State of North Carolina
State Contract N06009S
Schnabel Project No. 06210002.35

January 18, 2011

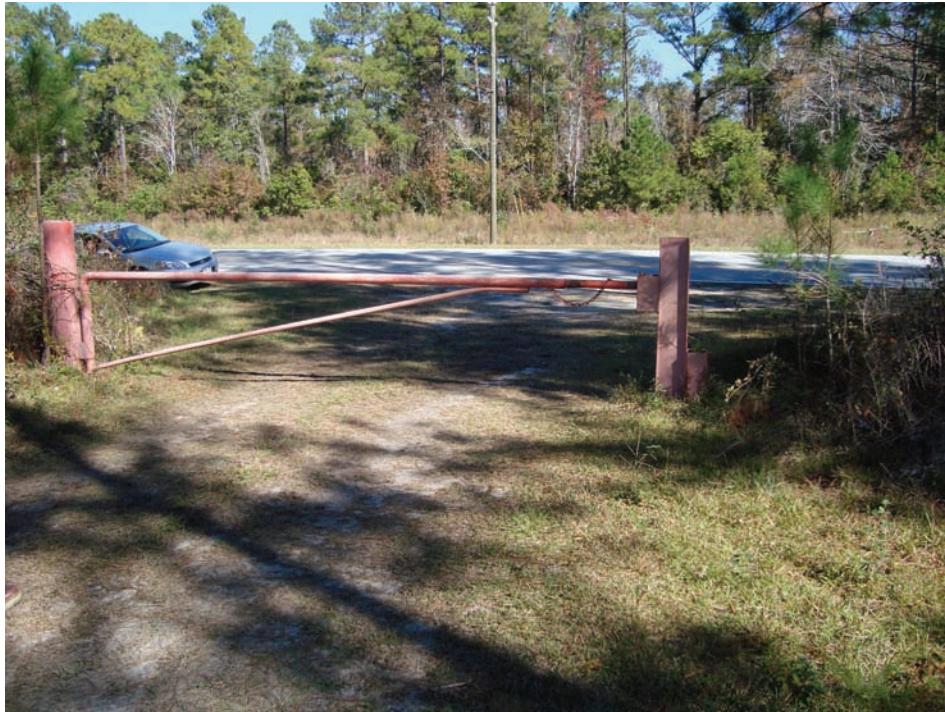
PHOTOGRAPH No.: 1

Access to the Disposal Area is from NC Highway 50 along a dirt road and through a gate (Photo 1). The Disposal Area occupies 19.4 acres based on the estimated Disposal Area perimeter shown on Figures 1 through 3.

Photo taken facing toward the east. Locked gate across the access road which leads to Disposal Area.

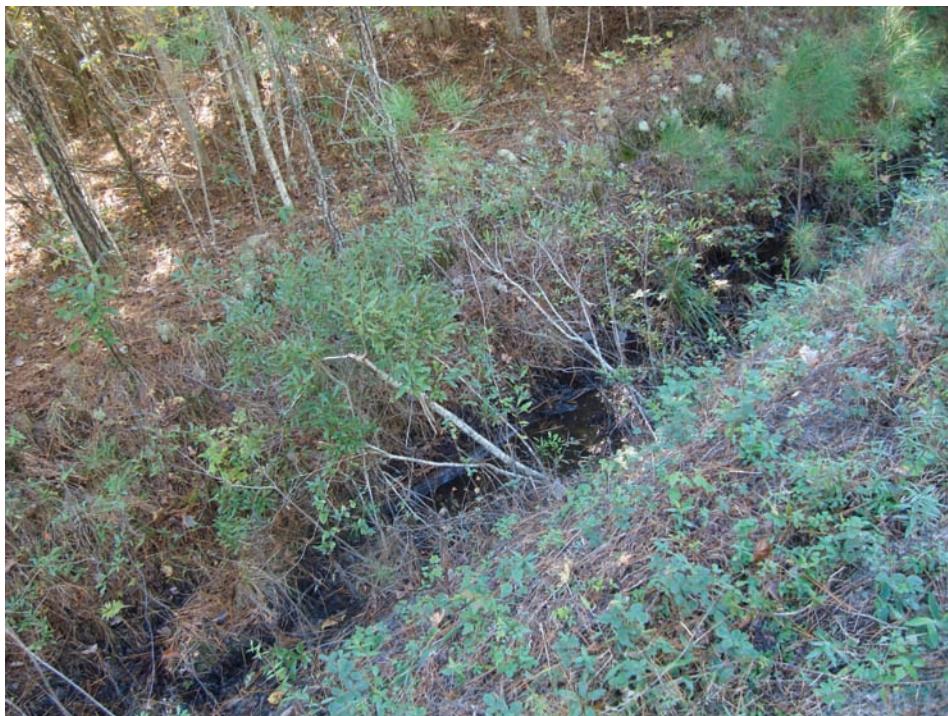
PHOTOGRAPH No.: 6

Ditches with standing water were located along northern and eastern perimeters of the Disposal Area (Photo 6).

Ditch with standing water

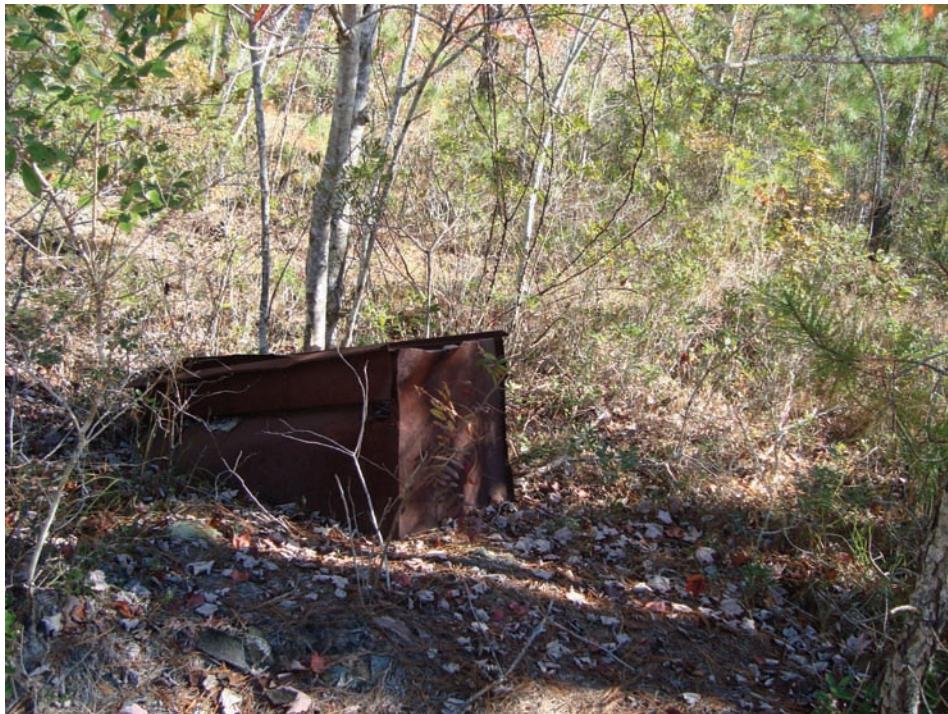
PHOTOGRAPH No.: 11

View of white goods.

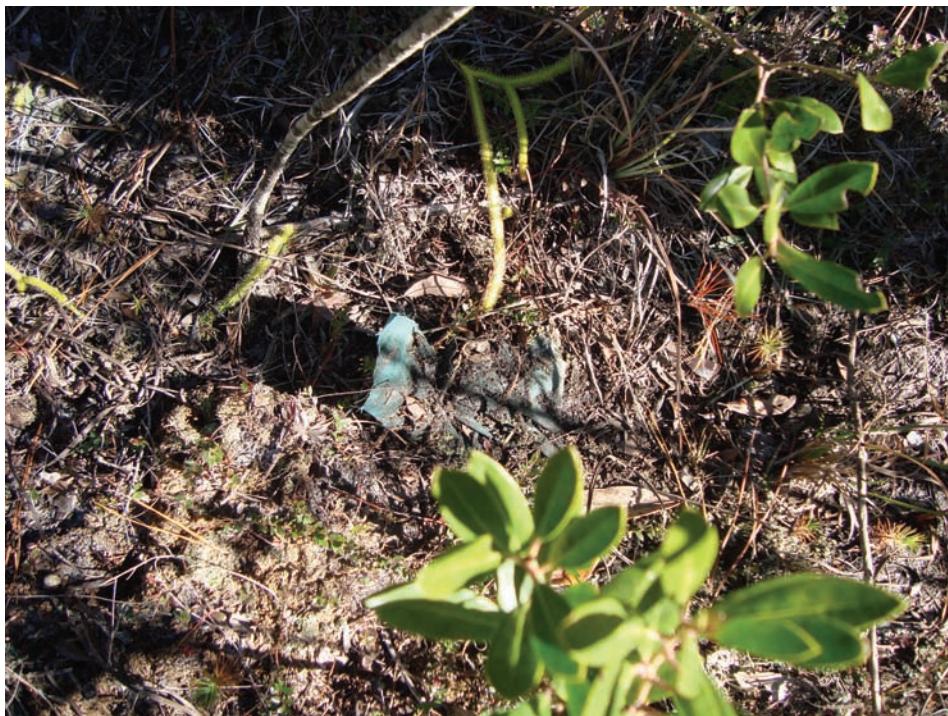
PHOTOGRAPH No.: 12

Fabric protruding from the ground surface.

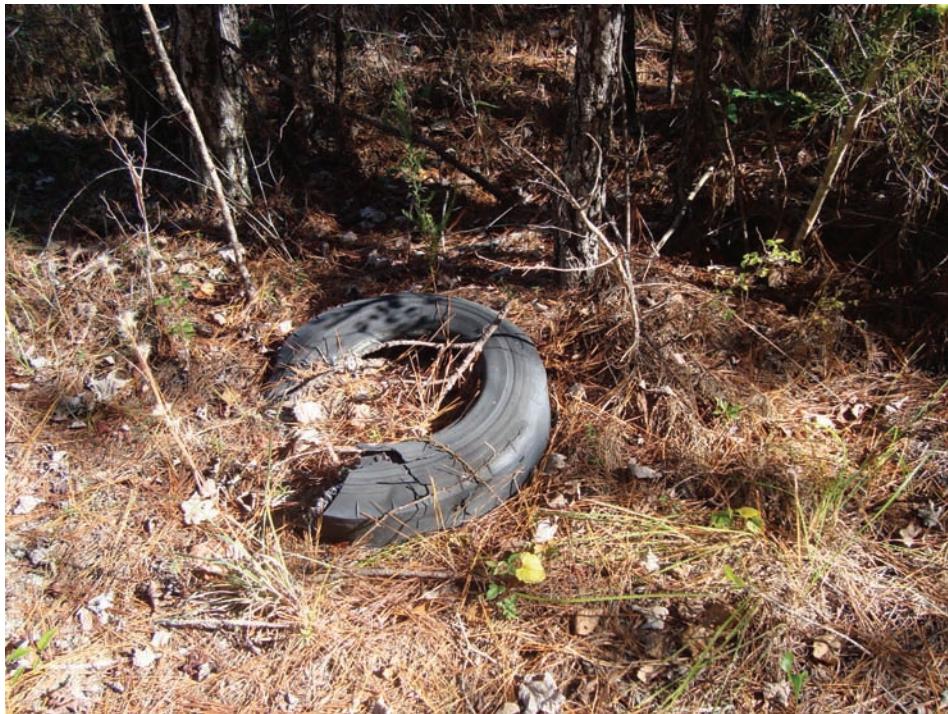
PHOTOGRAPH No.: 13

View of tire.

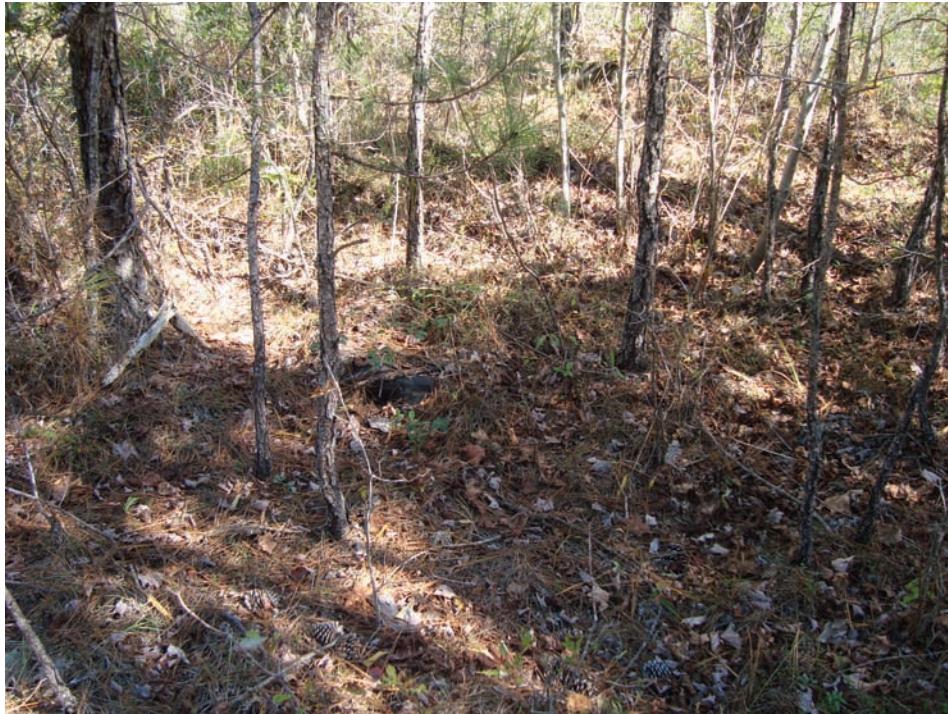
PHOTOGRAPH No.: 14

View of tire.

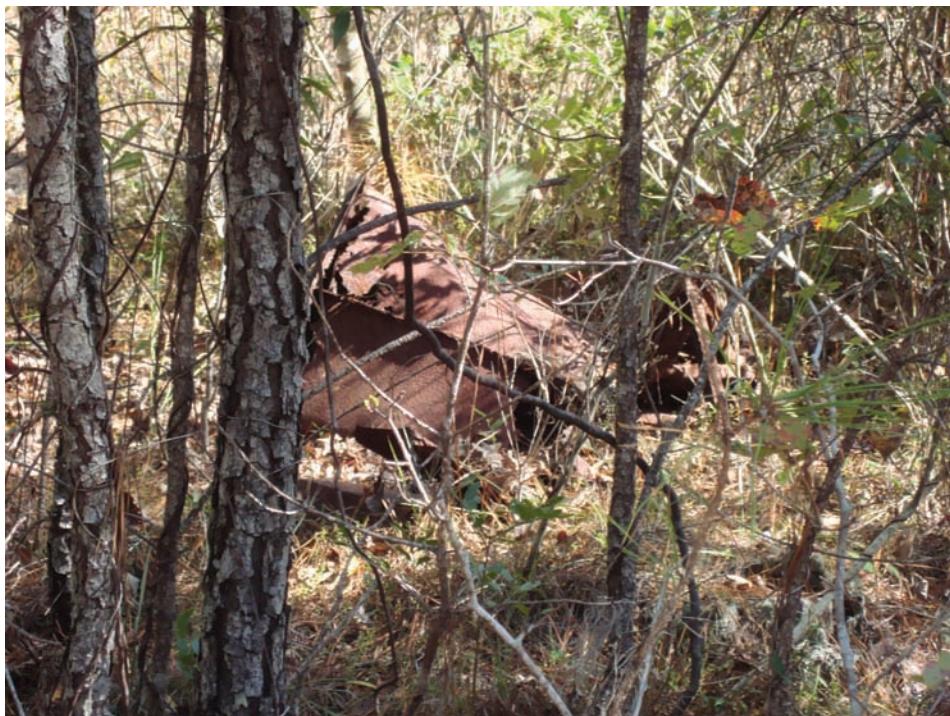
PHOTOGRAPH No.: 15

View of white goods.

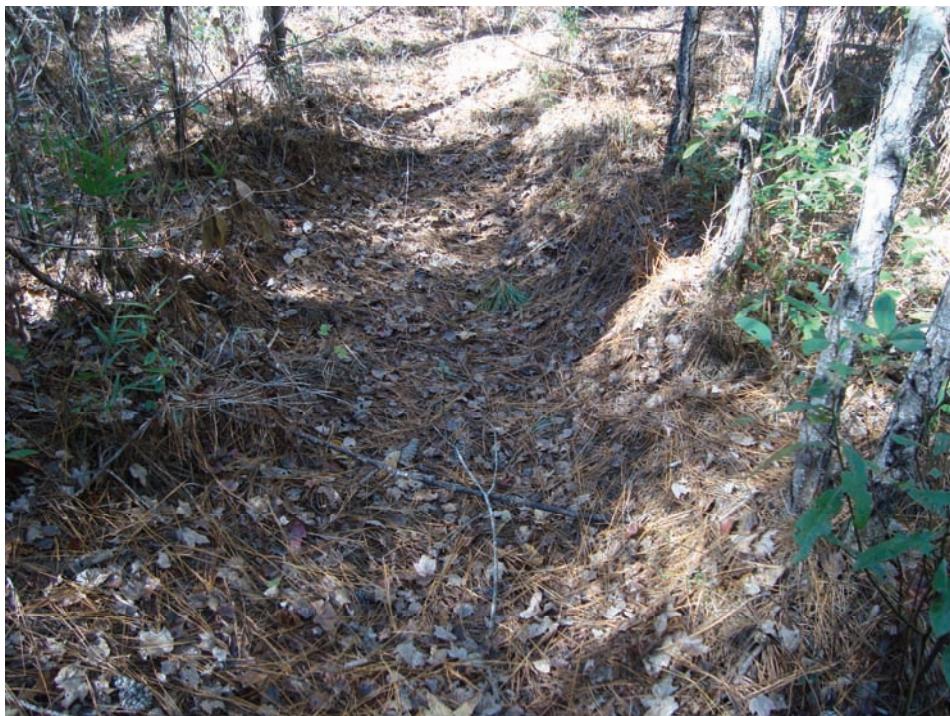
PHOTOGRAPH No.: 16

Trench features.

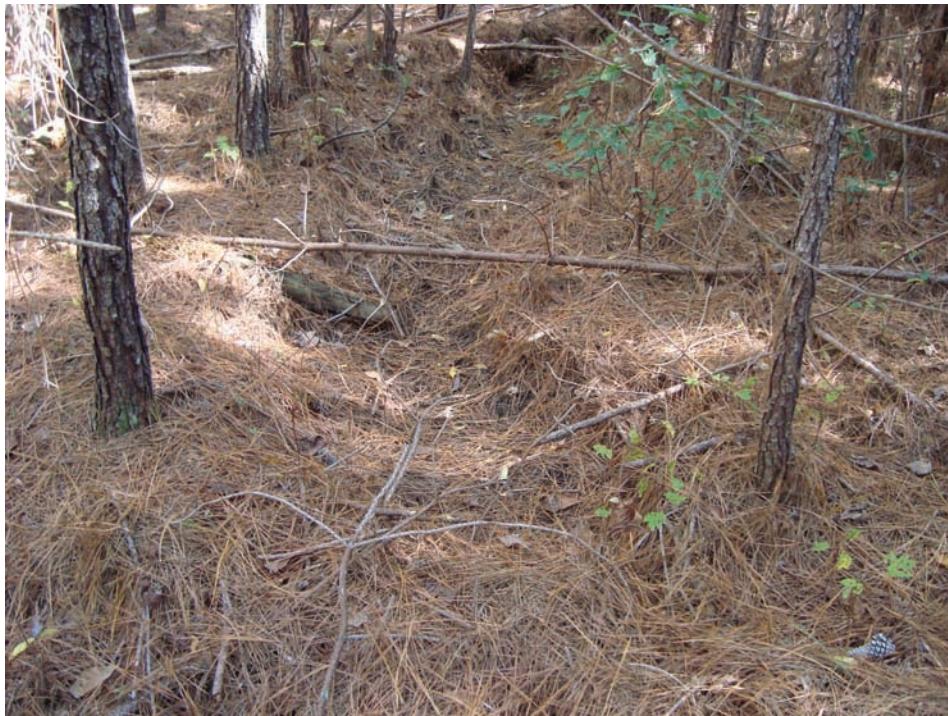
PHOTOGRAPH No.: 17

Trench features.

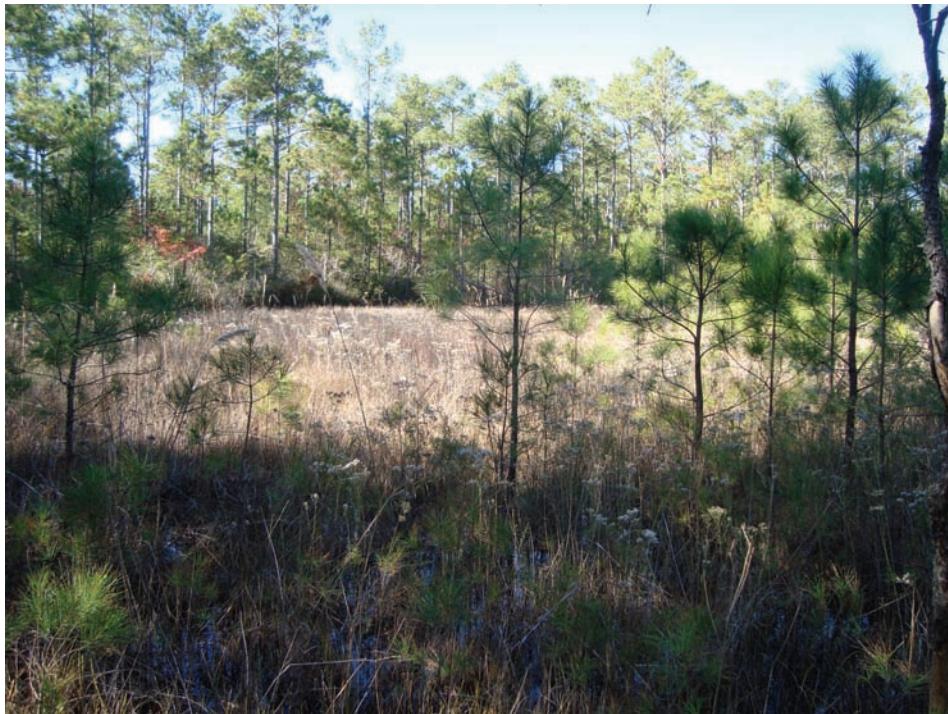
PHOTOGRAPH No.: 18

Marsh with standing water.
Photo taken facing west.

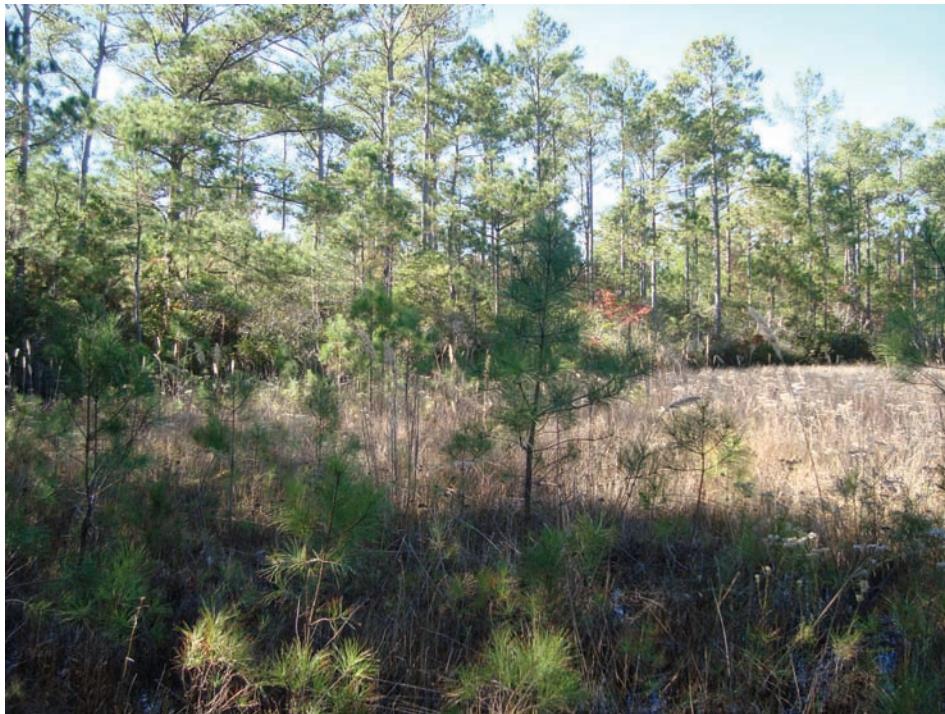
PHOTOGRAPH No.: 19

A marshy area with standing water is located near the eastern perimeter of the Disposal Area. The area is approximately 0.9 acres in size and was observed during the Site visit. Trees and vegetation were growing in the water. The water was clear and approximately two to eighteen inches in depth (Photos 19 and 20).

The Disposal Area was covered with grass, brush, and pine straw. A marsh with standing water approximately 0.9 acres in size is located on the eastern portion of the Disposal Area (Photos 19 and 20). The southern portion of the Disposal Area was covered with grass and brush. Visible debris, including white goods, automobile tires, and fabric were observed within the southern portion and near the western perimeter of the Disposal Area during the site visit. Brush and trees of up to 24 inches in diameter and a ground cover of pine straw were present on the northern and western portions of the Disposal Area, obscuring the surface. Trench features were present on the northern half of the Disposal Area (Photos 16 and 17). The trench features were uniform in size and were oriented in a north-south direction. Ditches with standing water were present on the northern and eastern perimeters of the Disposal Area.

Marsh. Photo taken facing toward the northwest.

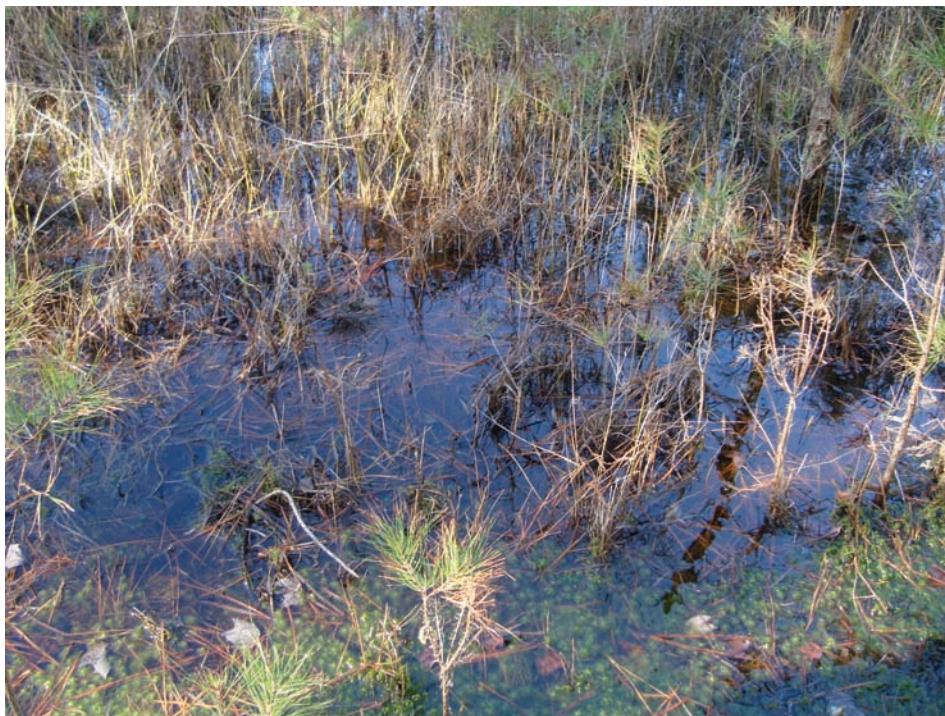
PHOTOGRAPH No.: 20

Standing water in the marsh.
