# Site Inspection Report

## Camp Davis Site

Holly Ridge, North Carolina

FUDS Project No. I04NC001702  
Contract: W912DY-04-D-0005  
Task Order: 0008

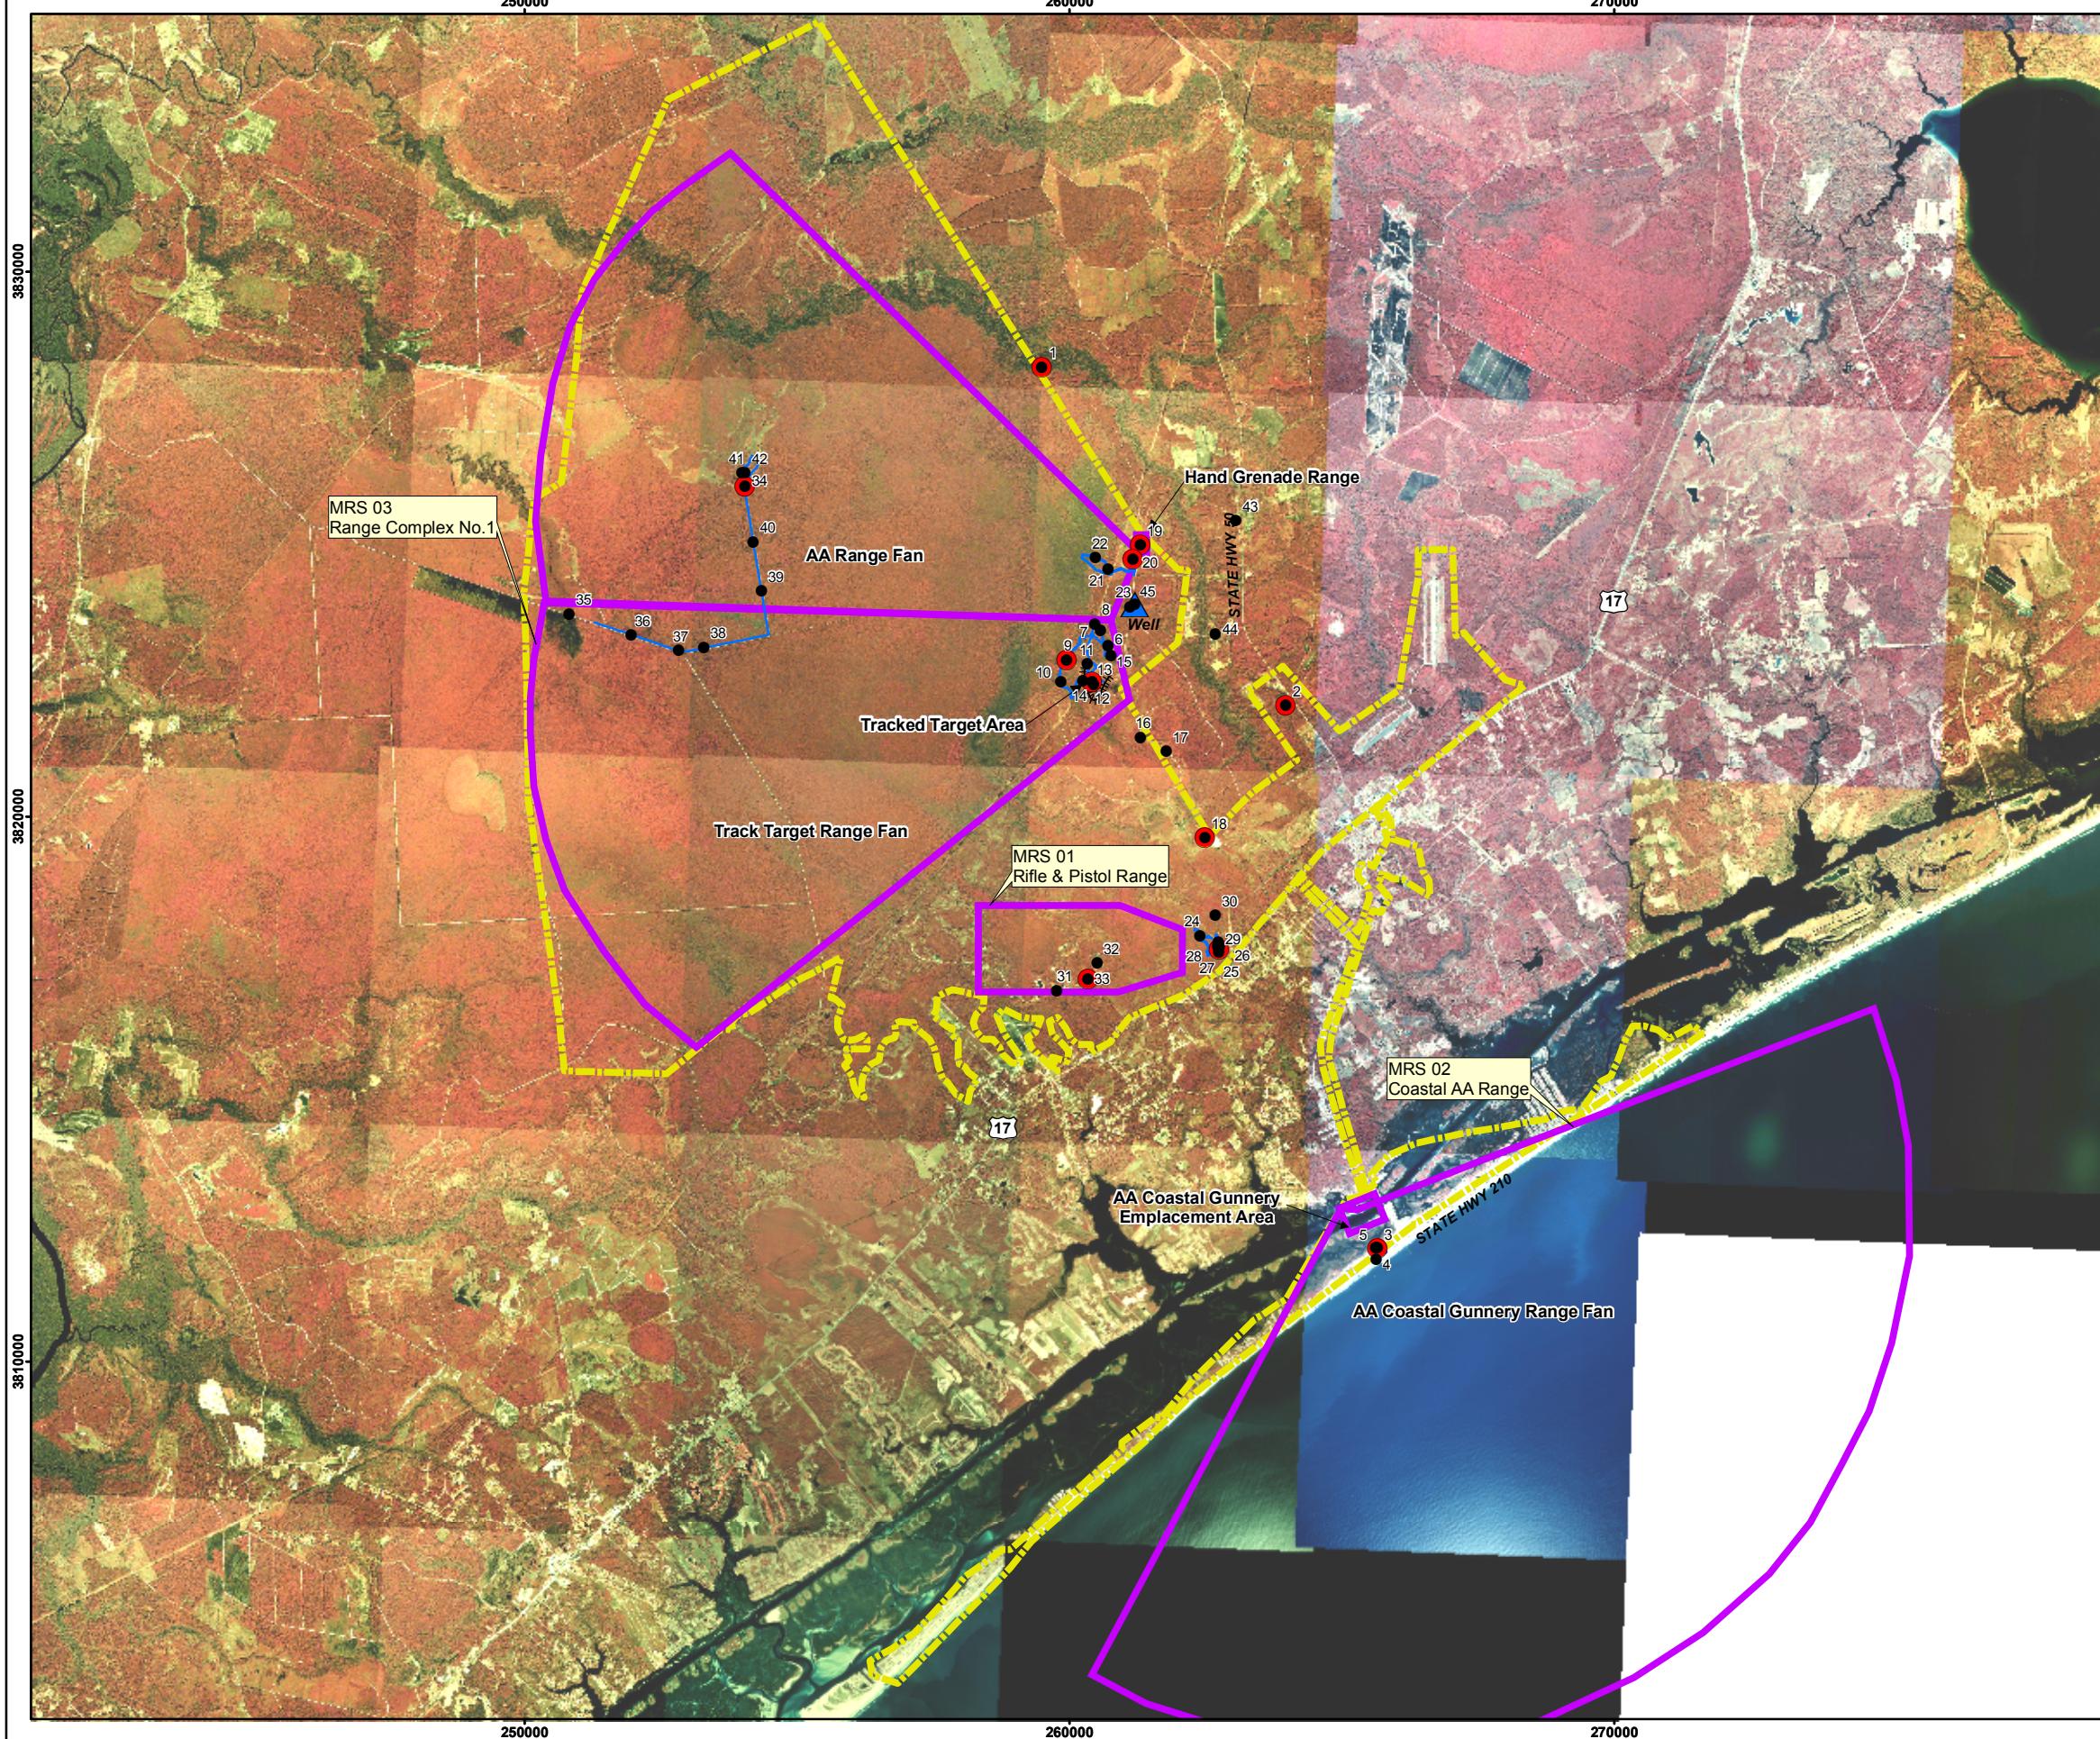
## Qualitative Reconnaissance and Field Observation Locations Camp Davis

4.1.3 QR was conducted along the routes prescribed in the SS-WP Addendum (Parsons, 2007); due to the extensive presence of pocosin swamp which was often impassable, the majority of the QR path was modified. The team recorded field observations regarding found debris, unique site features, visual indicators of munitions use, or if a sample was collected. Additionally, observations were recorded when there was a change in terrain, vegetation, presence of pocosin swamp, or when roads or other barriers were encountered. Figure 4.1 shows the QR routes and observation locations. The observation location numbers correspond to the photo station numbers documented in the photo documentation log (Appendix E). The QR route was not limited to the proposed path depicted in the SS-WP Addendum, but was determined in the field by the field team leader (FTL) based on considerations such as location, site size and complexity, vegetation, professional judgment, and areas of predetermined focus (Parsons, 2005). Table 4.1 presents the potential MEC anticipated to be present at the site based on the ASR and ASR Supplement. The potential constituents of the supposed MEC are also listed in this table. The MEC conceptual site model (CSM) and conceptual site exposure model (CSEM) are included in Appendix J.

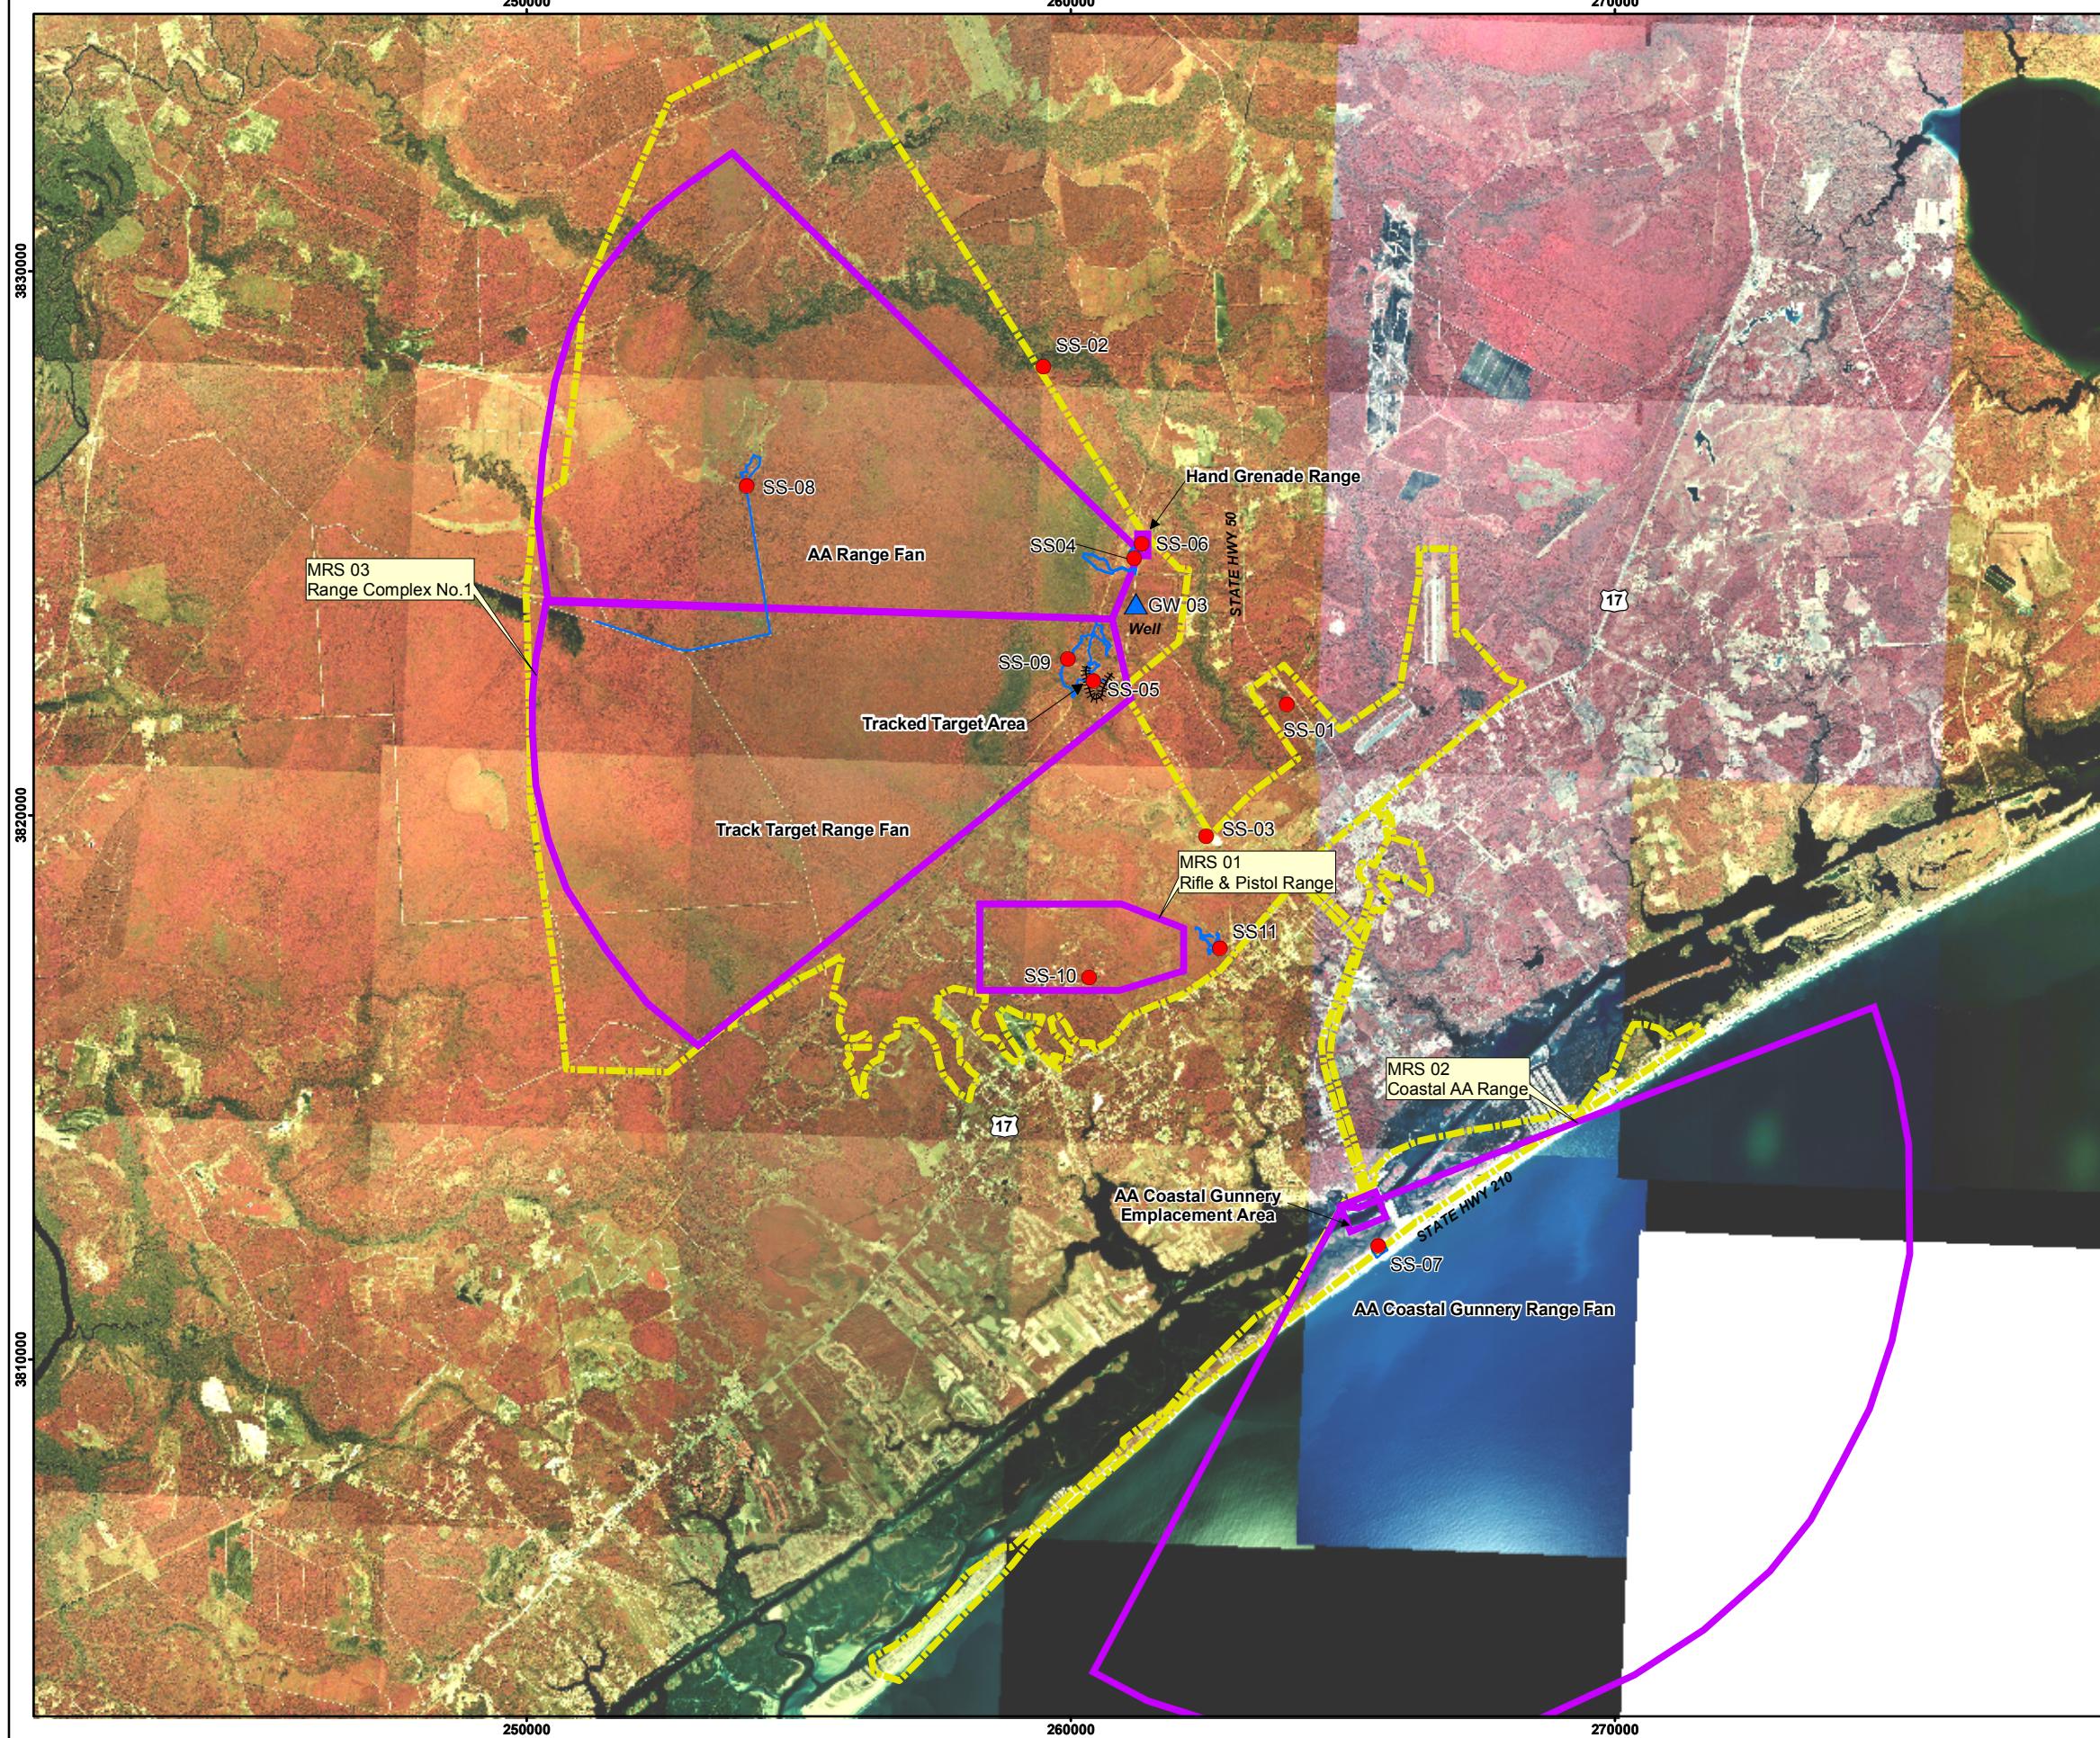
## Qualitative Reconnaissance and Sample Locations Camp Davis

5.2.6.6 Several of the soil samples were moved based either on findings in the field or due to concerns of potential contamination from non-DoD sources. Sample CD-MRS03-SS-02-04 was moved from its proposed location to an area where an unexpended .30 round and a .50 caliber casing were found (the only items found on the ground in the MRS). Sample CD-MRS03-SS-02-05 was moved from its proposed location to the base of the berm located in the track target area of the MRS. Ambient sample CD-MRS03-SS-02-03 was moved from its proposed location to an alternate location in the Remaining Lands portion of the FUDS, as it was initially placed within 300 feet of an abandoned automobile race track. Sample CD-MRS03-SS-02-08 was moved from its planned position as the soil was obviously transported in from another location to construct a road through the pocosin and placed at a point approximately one-eighth of a mile to the west where soil was undisturbed. Sample CD-MRS01-SS-02-11 was moved to the base of a rifle range backstop to assess potential soil contamination in the area. Due to the heavy growth of pocosin swamp in most of the Rifle & Pistol Range MRS and privately owned residential properties in the area of the proposed sample, Sample CD-MRS03-SS-02-10 was placed in an area of the MRS that was accessible. Much of the proposed QR route was modified due to the heavy vegetation in the pocosin swamp and presence of residential properties (in the Rifle & Pistol Range MRS only). The QR path in the Rifle & Pistol Range MRS was also modified due to the observance of four actual concrete backstops along the firing line. The updated soil sample locations and QR paths have been illustrated on Figure 5.2

5.2.7.3 To provide an indication of the range of concentrations of metals naturally present at the site, three ambient surface soil samples (CD-AMB-SS-02-01, CD-AMB-SS-02-02, and CD-AMB-SS-02-03), as shown in Figure 5.2, were collected during the SI. Owing to this small number of samples, calculation of a more statistically robust site-specific background value is not possible. However, these ambient samples provide an indication of the range of naturally occurring metals concentrations. These samples were collected outside the MRS. No MEC or MD were observed in the areas of the ambient sample locations, suggesting that these locations are representative of the naturally occurring soils in the area. No explosives were detected in any of the ambient samples.
